RAISING EFFICIENCY IN PHOTOVOLTAIC SYSTEMS: HIGH RESOLUTION MONITORING AND PERFORMANCE ANALYSIS

S. K. FIRTH

The Institute of Energy and Sustainable Development
De Montfort University

A thesis submitted in partial fulfilment of the requirements of
De Montfort University for the degree of Doctor of Philosophy

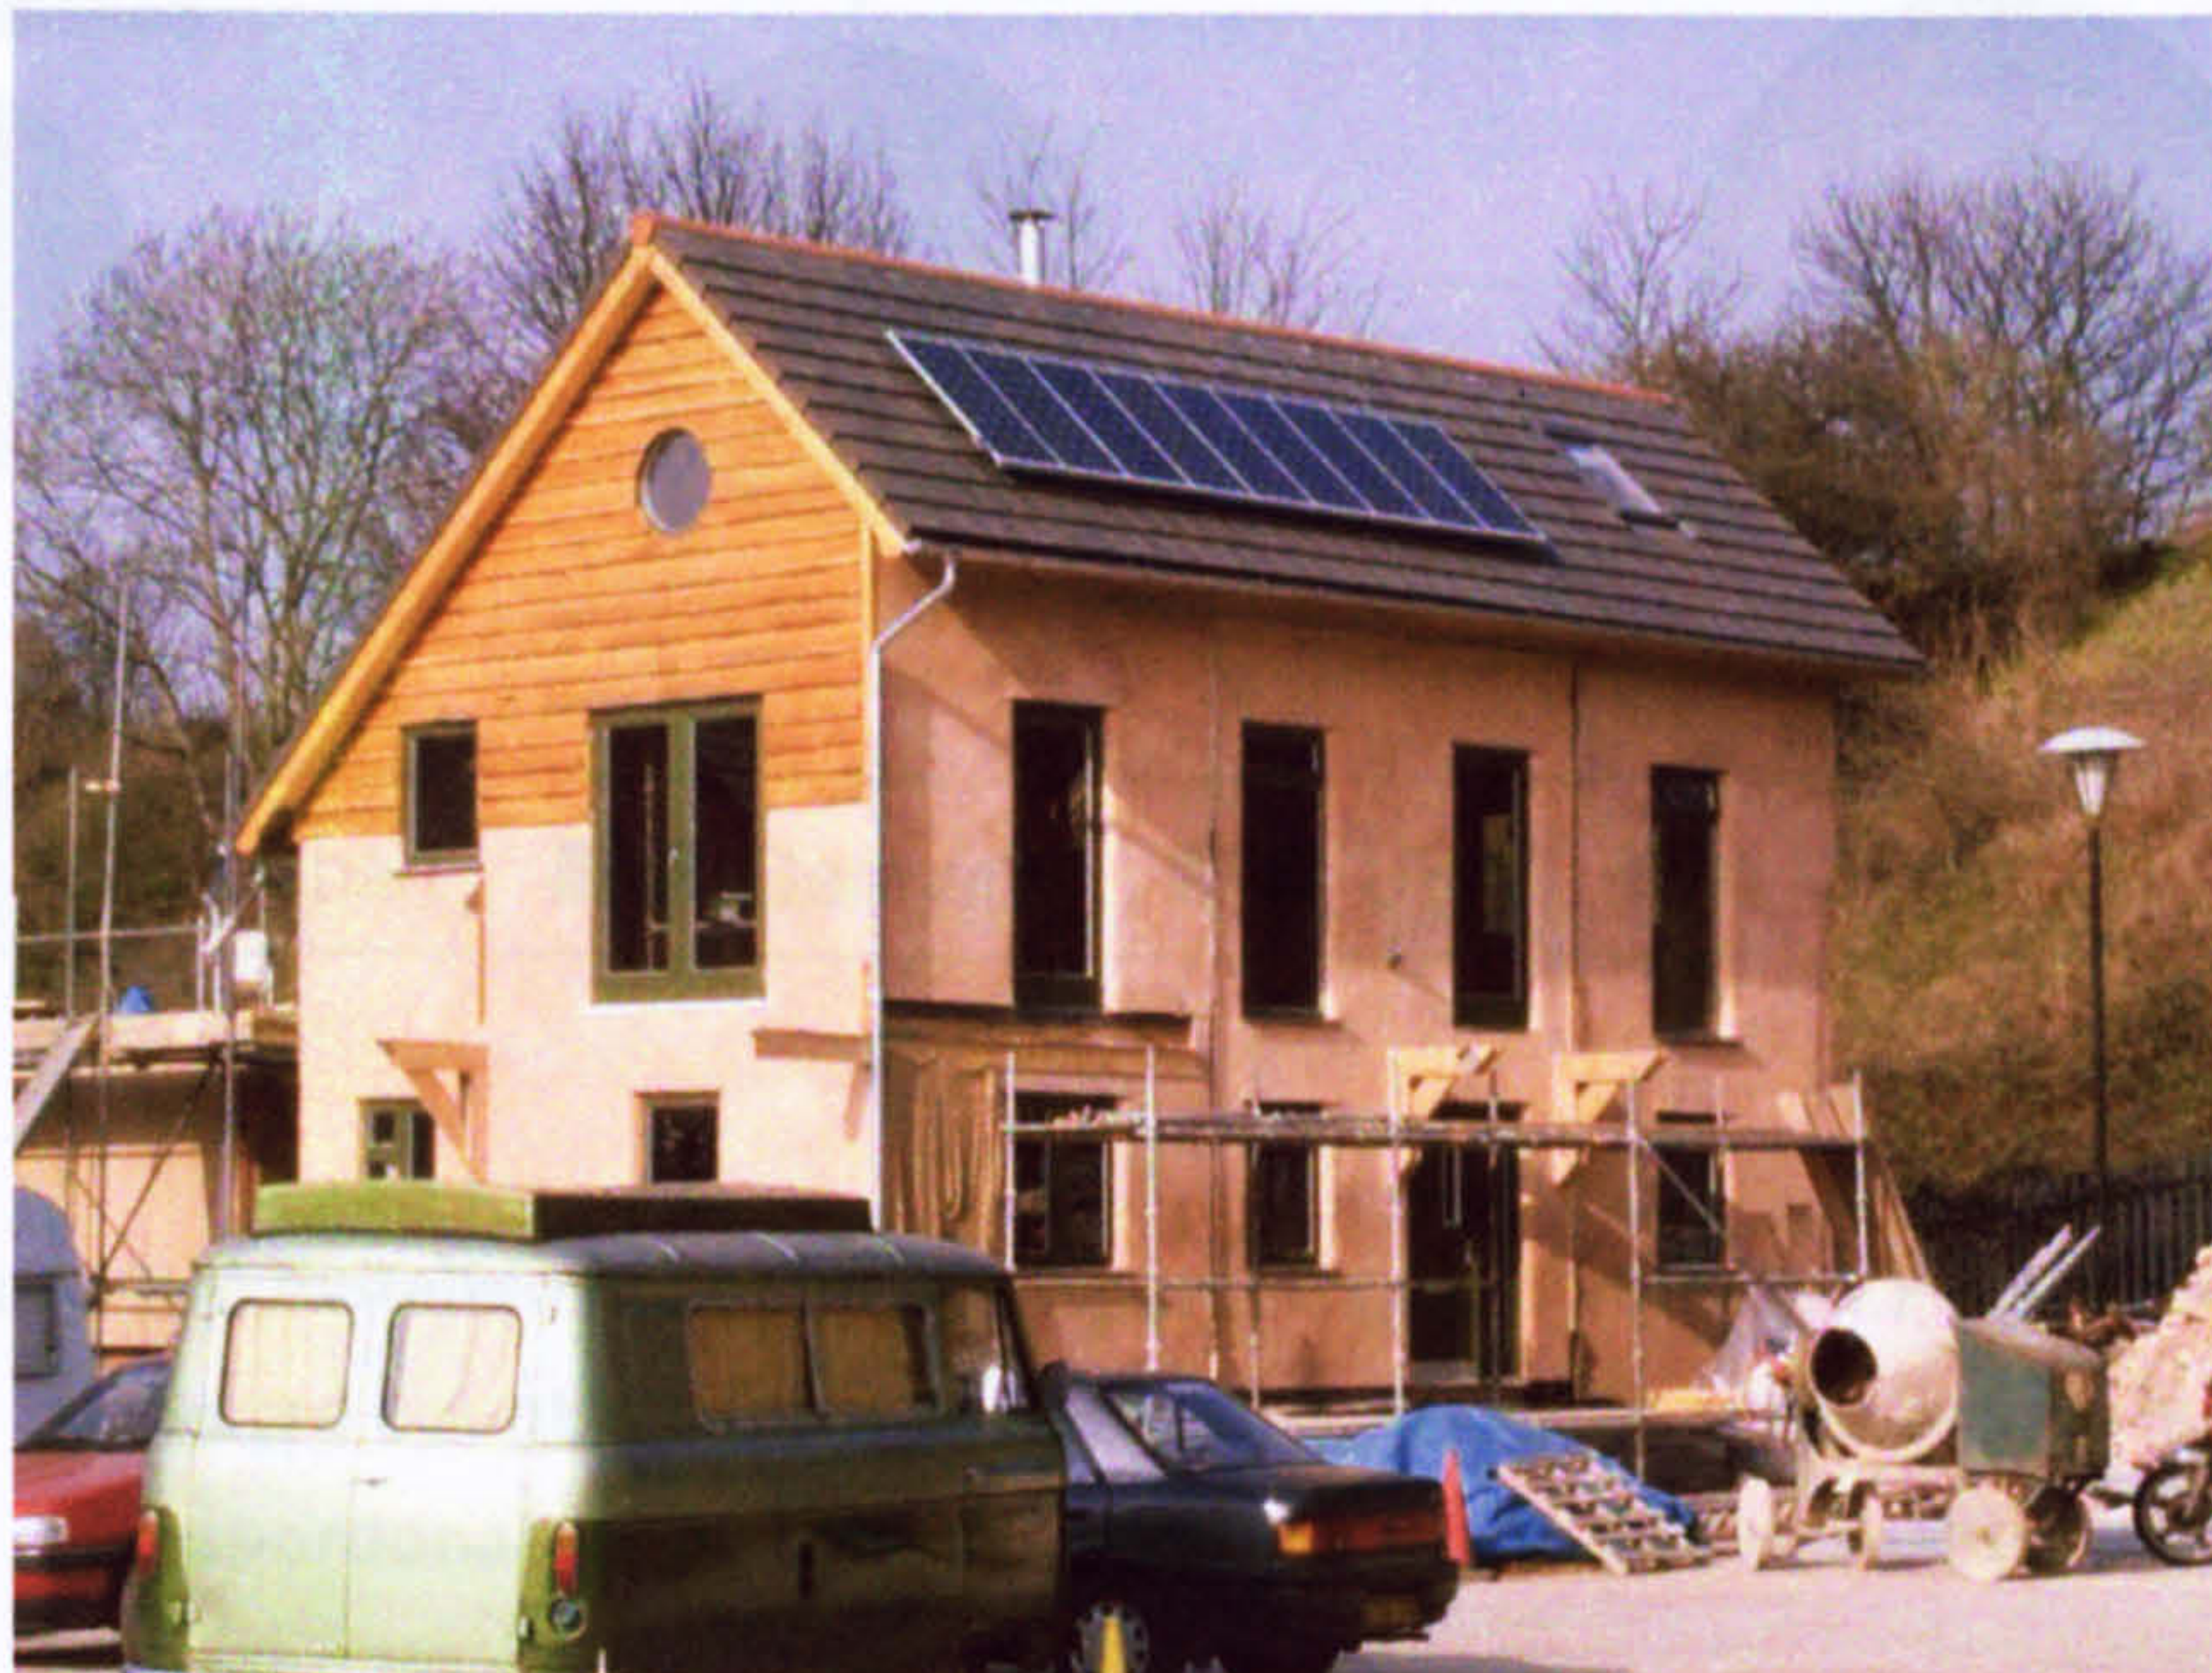
system in the UK is shown in Figure 1-1. This PV system, installed in 2003, consists of nine PV modules³ in a PV array⁴ mounted on a south facing roof and is one of the PV systems being studied in this work.

**Figure 1-1: A recent UK domestic PV system
(installed under the UK Government's Domestic Field Trial)**

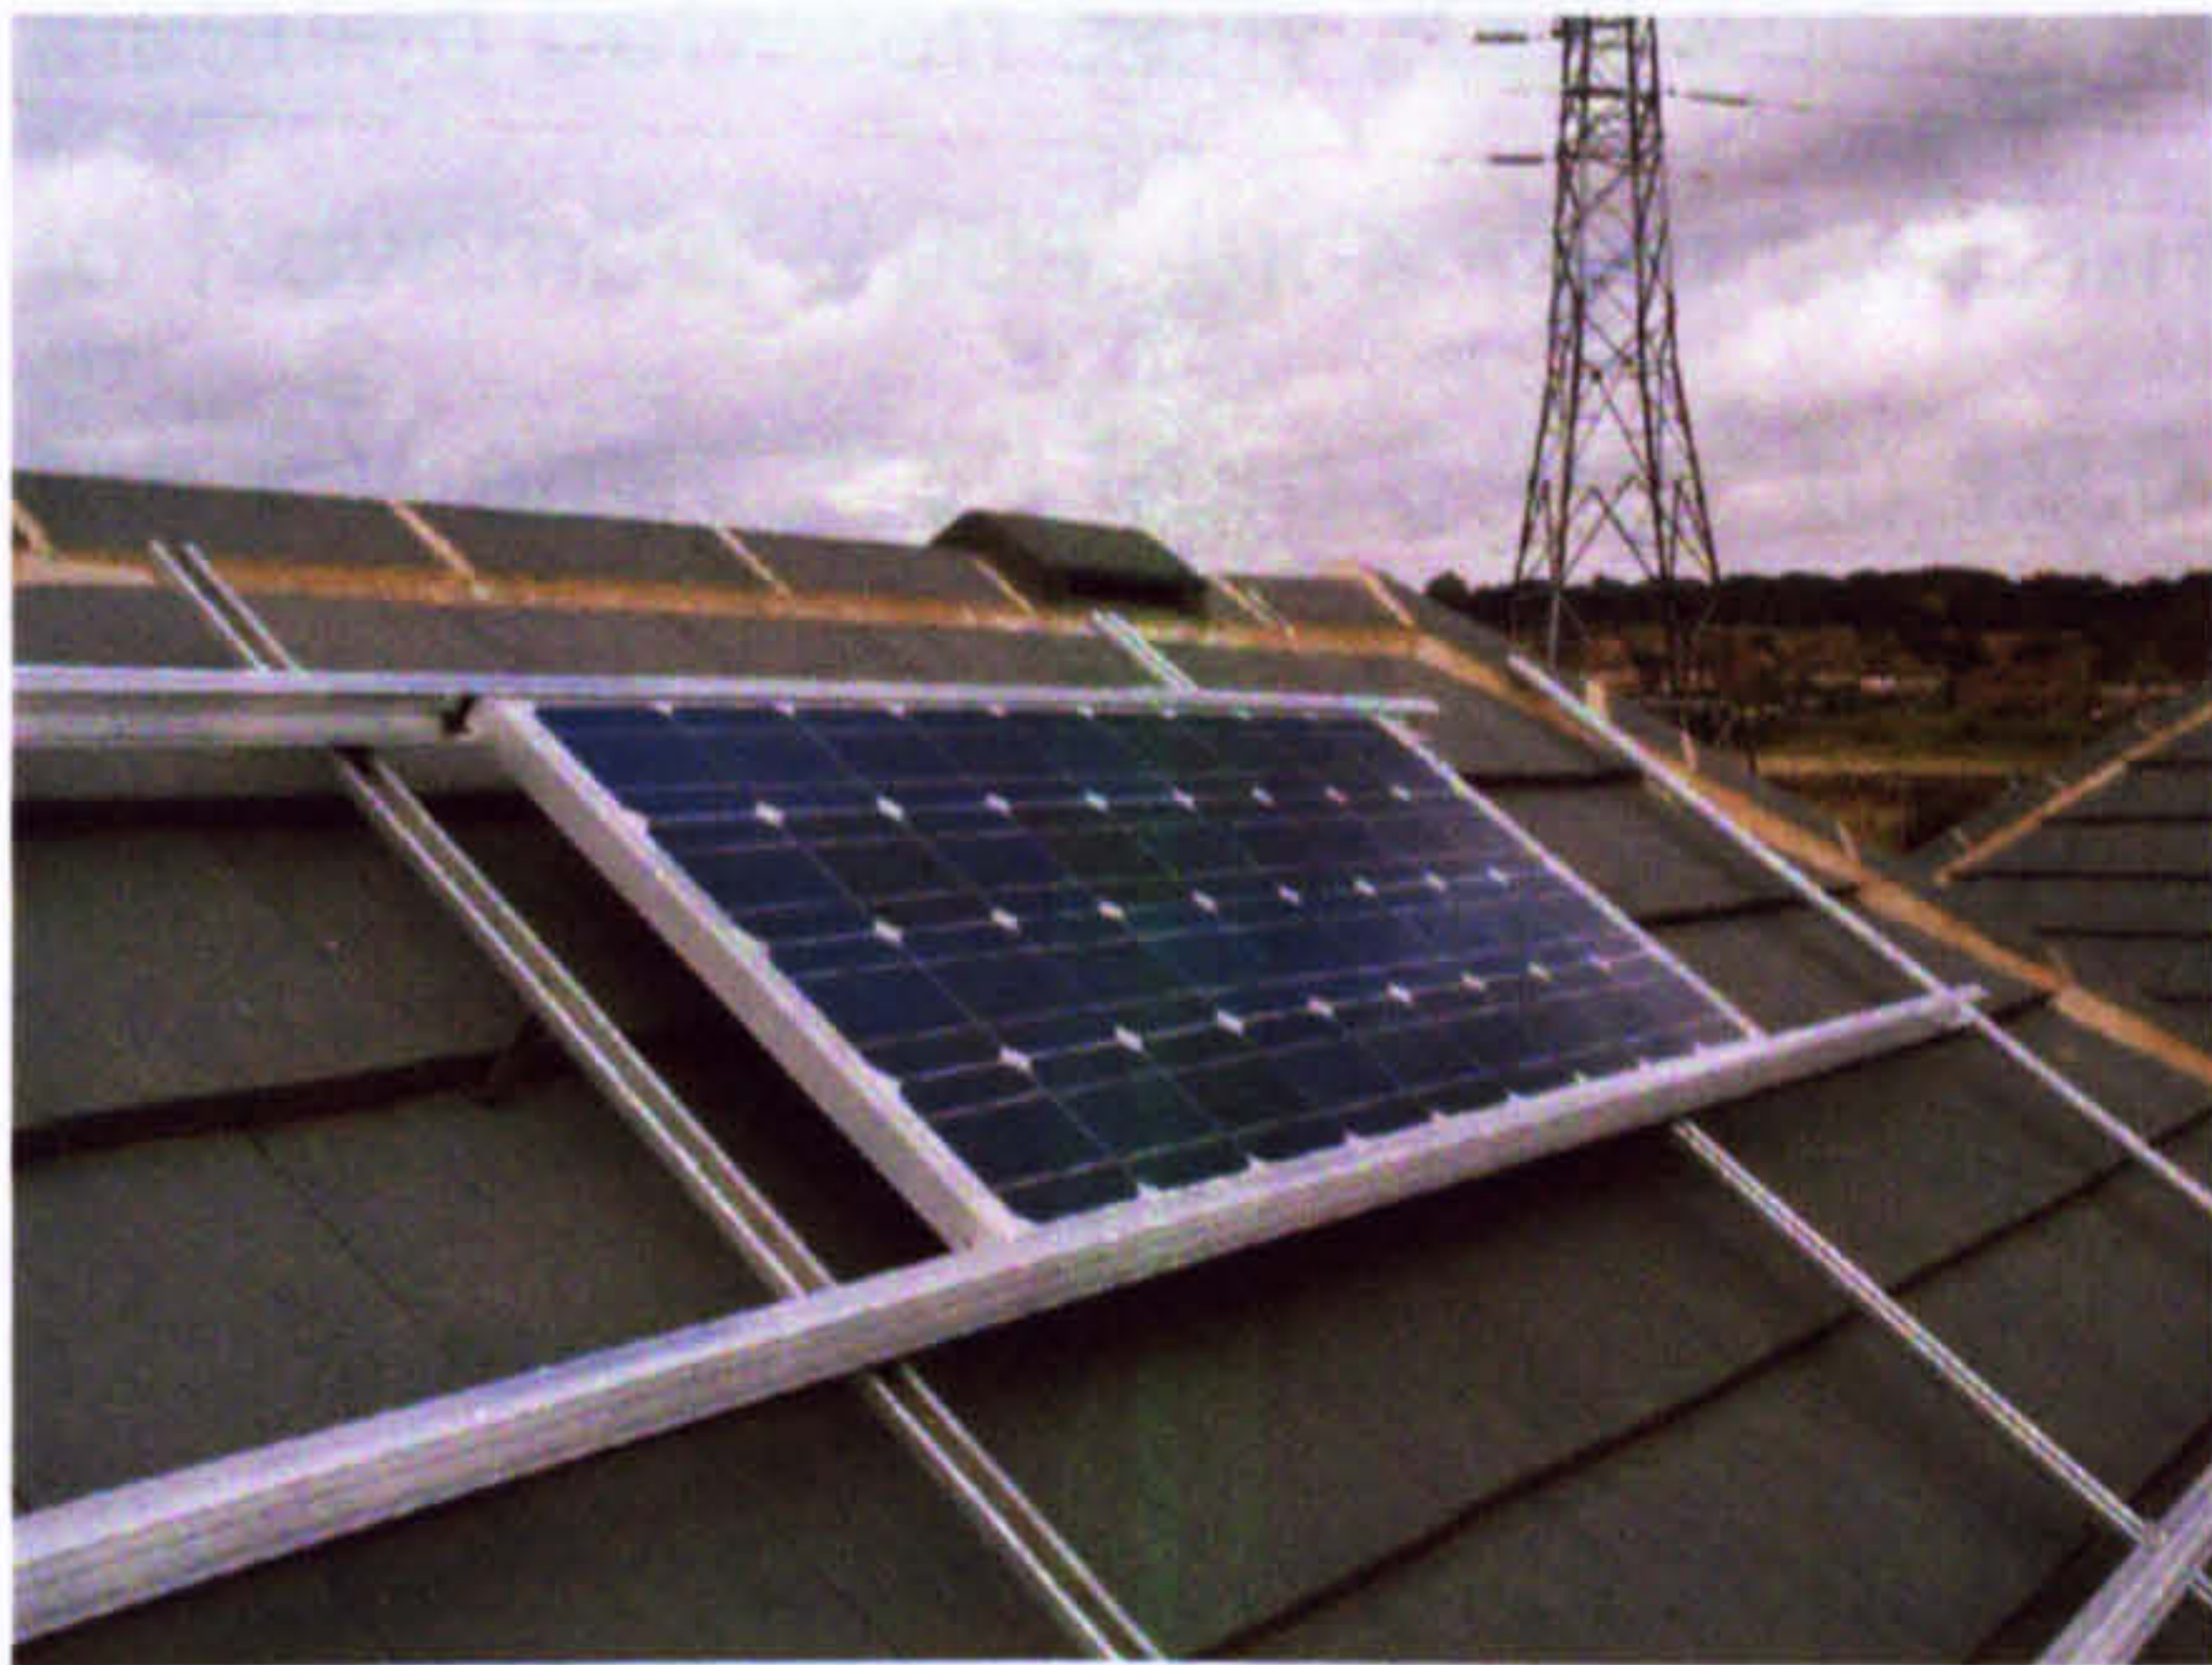
Figure 3-2: A single PV module on a bolt-on mounting system (Heron Close)

The PV arrays are installed on the roofs of the buildings using two distinct methods. *Bolt-on* mounting systems use specially constructed frames to mount the PV modules over the building surface (Figure 3-2). There is an air gap between the PV modules and the building surface, typically of 10 to 15 cm. In *integrated* systems the PV modules are part of the building envelope (Figure 3-3). The modules form a part of the roof, wall or façade and act as a building material protecting the building from the weather as well as generating electricity. Integrated systems can reduce overall costs as the PV modules replace some of the building materials.

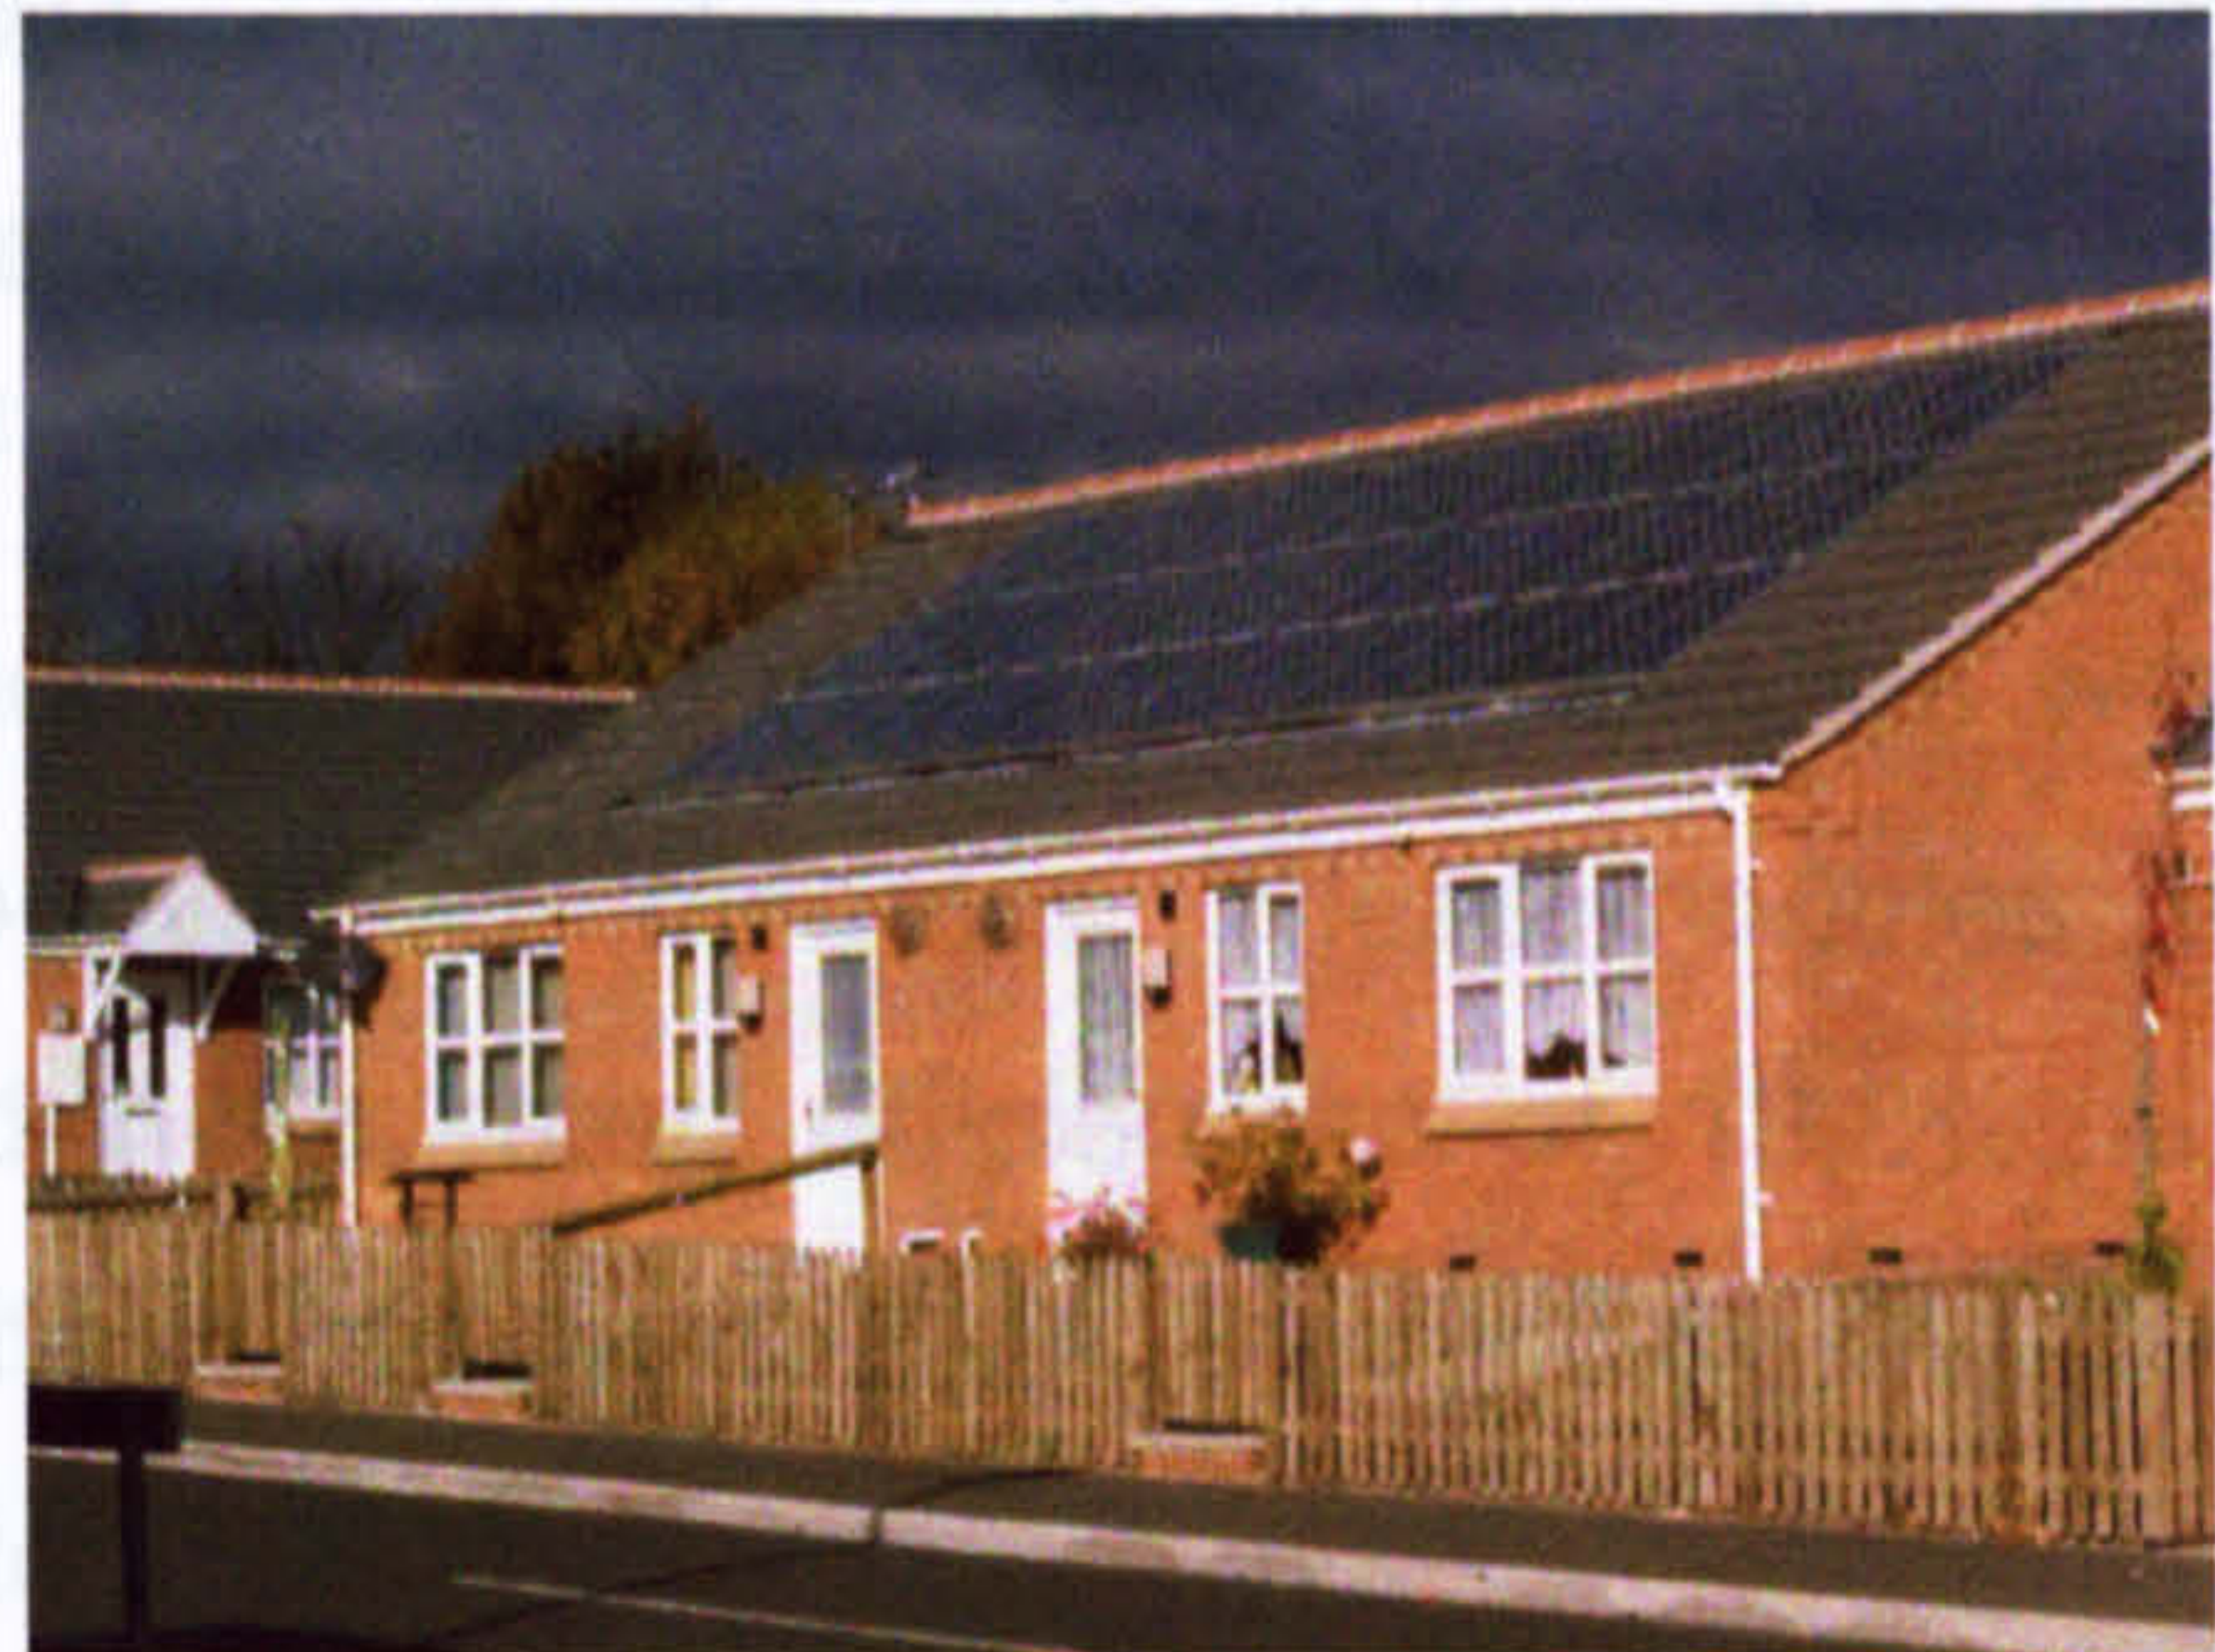
Figure 3-3: A complete PV array integrated into a roof (Corncroft)

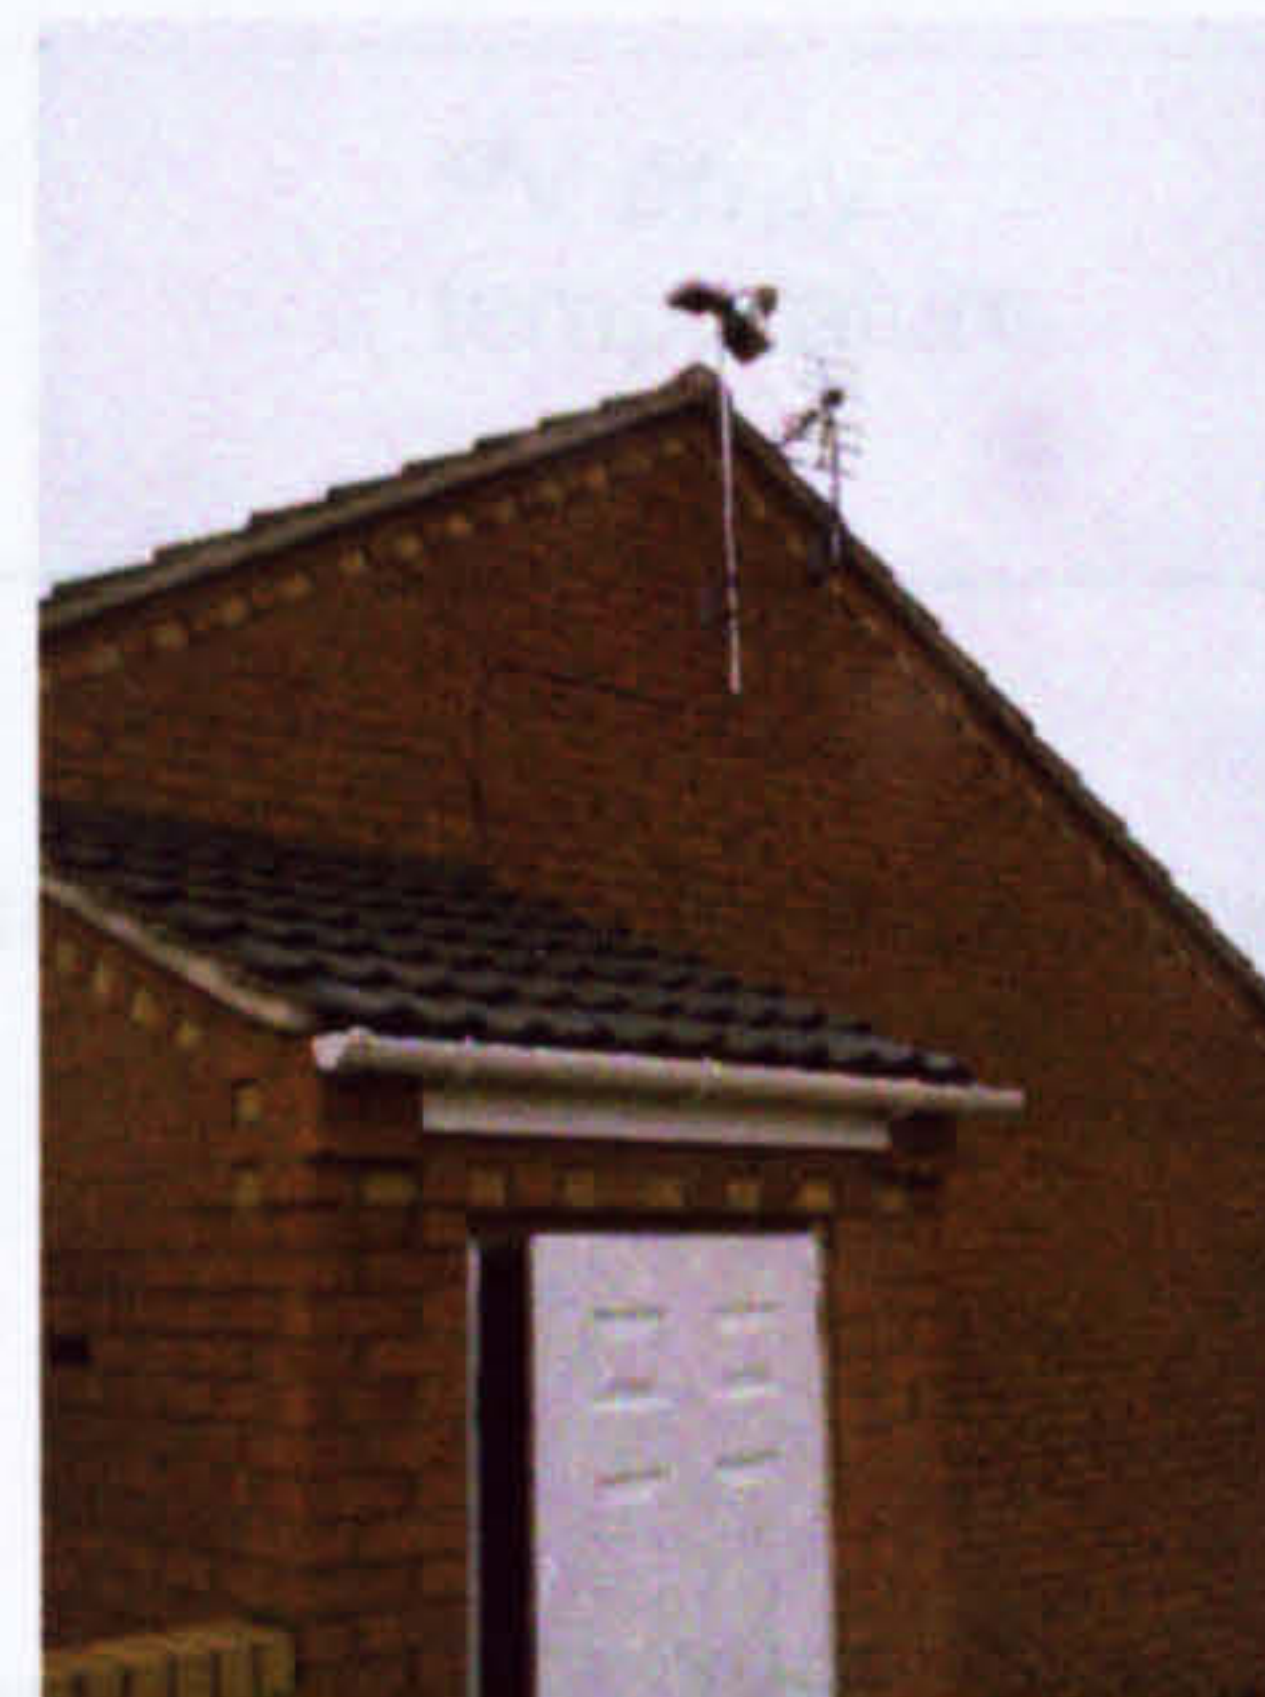
Figure 3-7: Horizontal and in plane radiation sensors mounted on a bracket above the ridge of the roof at Corncroft. The ambient temperature sensor is also mounted on the bracket.

As already mentioned, solar radiation was measured both horizontally and in the plane of the PV array. The horizontal radiation was measured at one location for each site and the in-plane solar radiation was measured for each group of PV arrays with similar orientations (only once if all the arrays on site had the same orientation). The radiation sensors should be unshaded throughout the year and if possible were placed above the ridge of the roof (Figure 3-6 and Figure 3-7). There were instances when the radiation sensors were shaded and the effect of this is discussed in Chapter 5.

EETS (EETS, 2005) and Sensol (ISET, 2005) radiation sensors are used, both consisting of a small PV cell of crystalline semiconductor silicon (Table 3-4). The short circuit current¹³ of the PV cell is measured and used to calculate the solar irradiance. As the short circuit current in a PV cell varies proportionally with the number of photons absorbed by the cell (as described in Green (Green, 1982)), the sensor is essentially a photon counter. The sensors output a voltage signal which is proportional to the short circuit current of the PV cell. The voltage signal, typically around 0 mV to 60 mV, is measured by the data loggers and used to calculate the

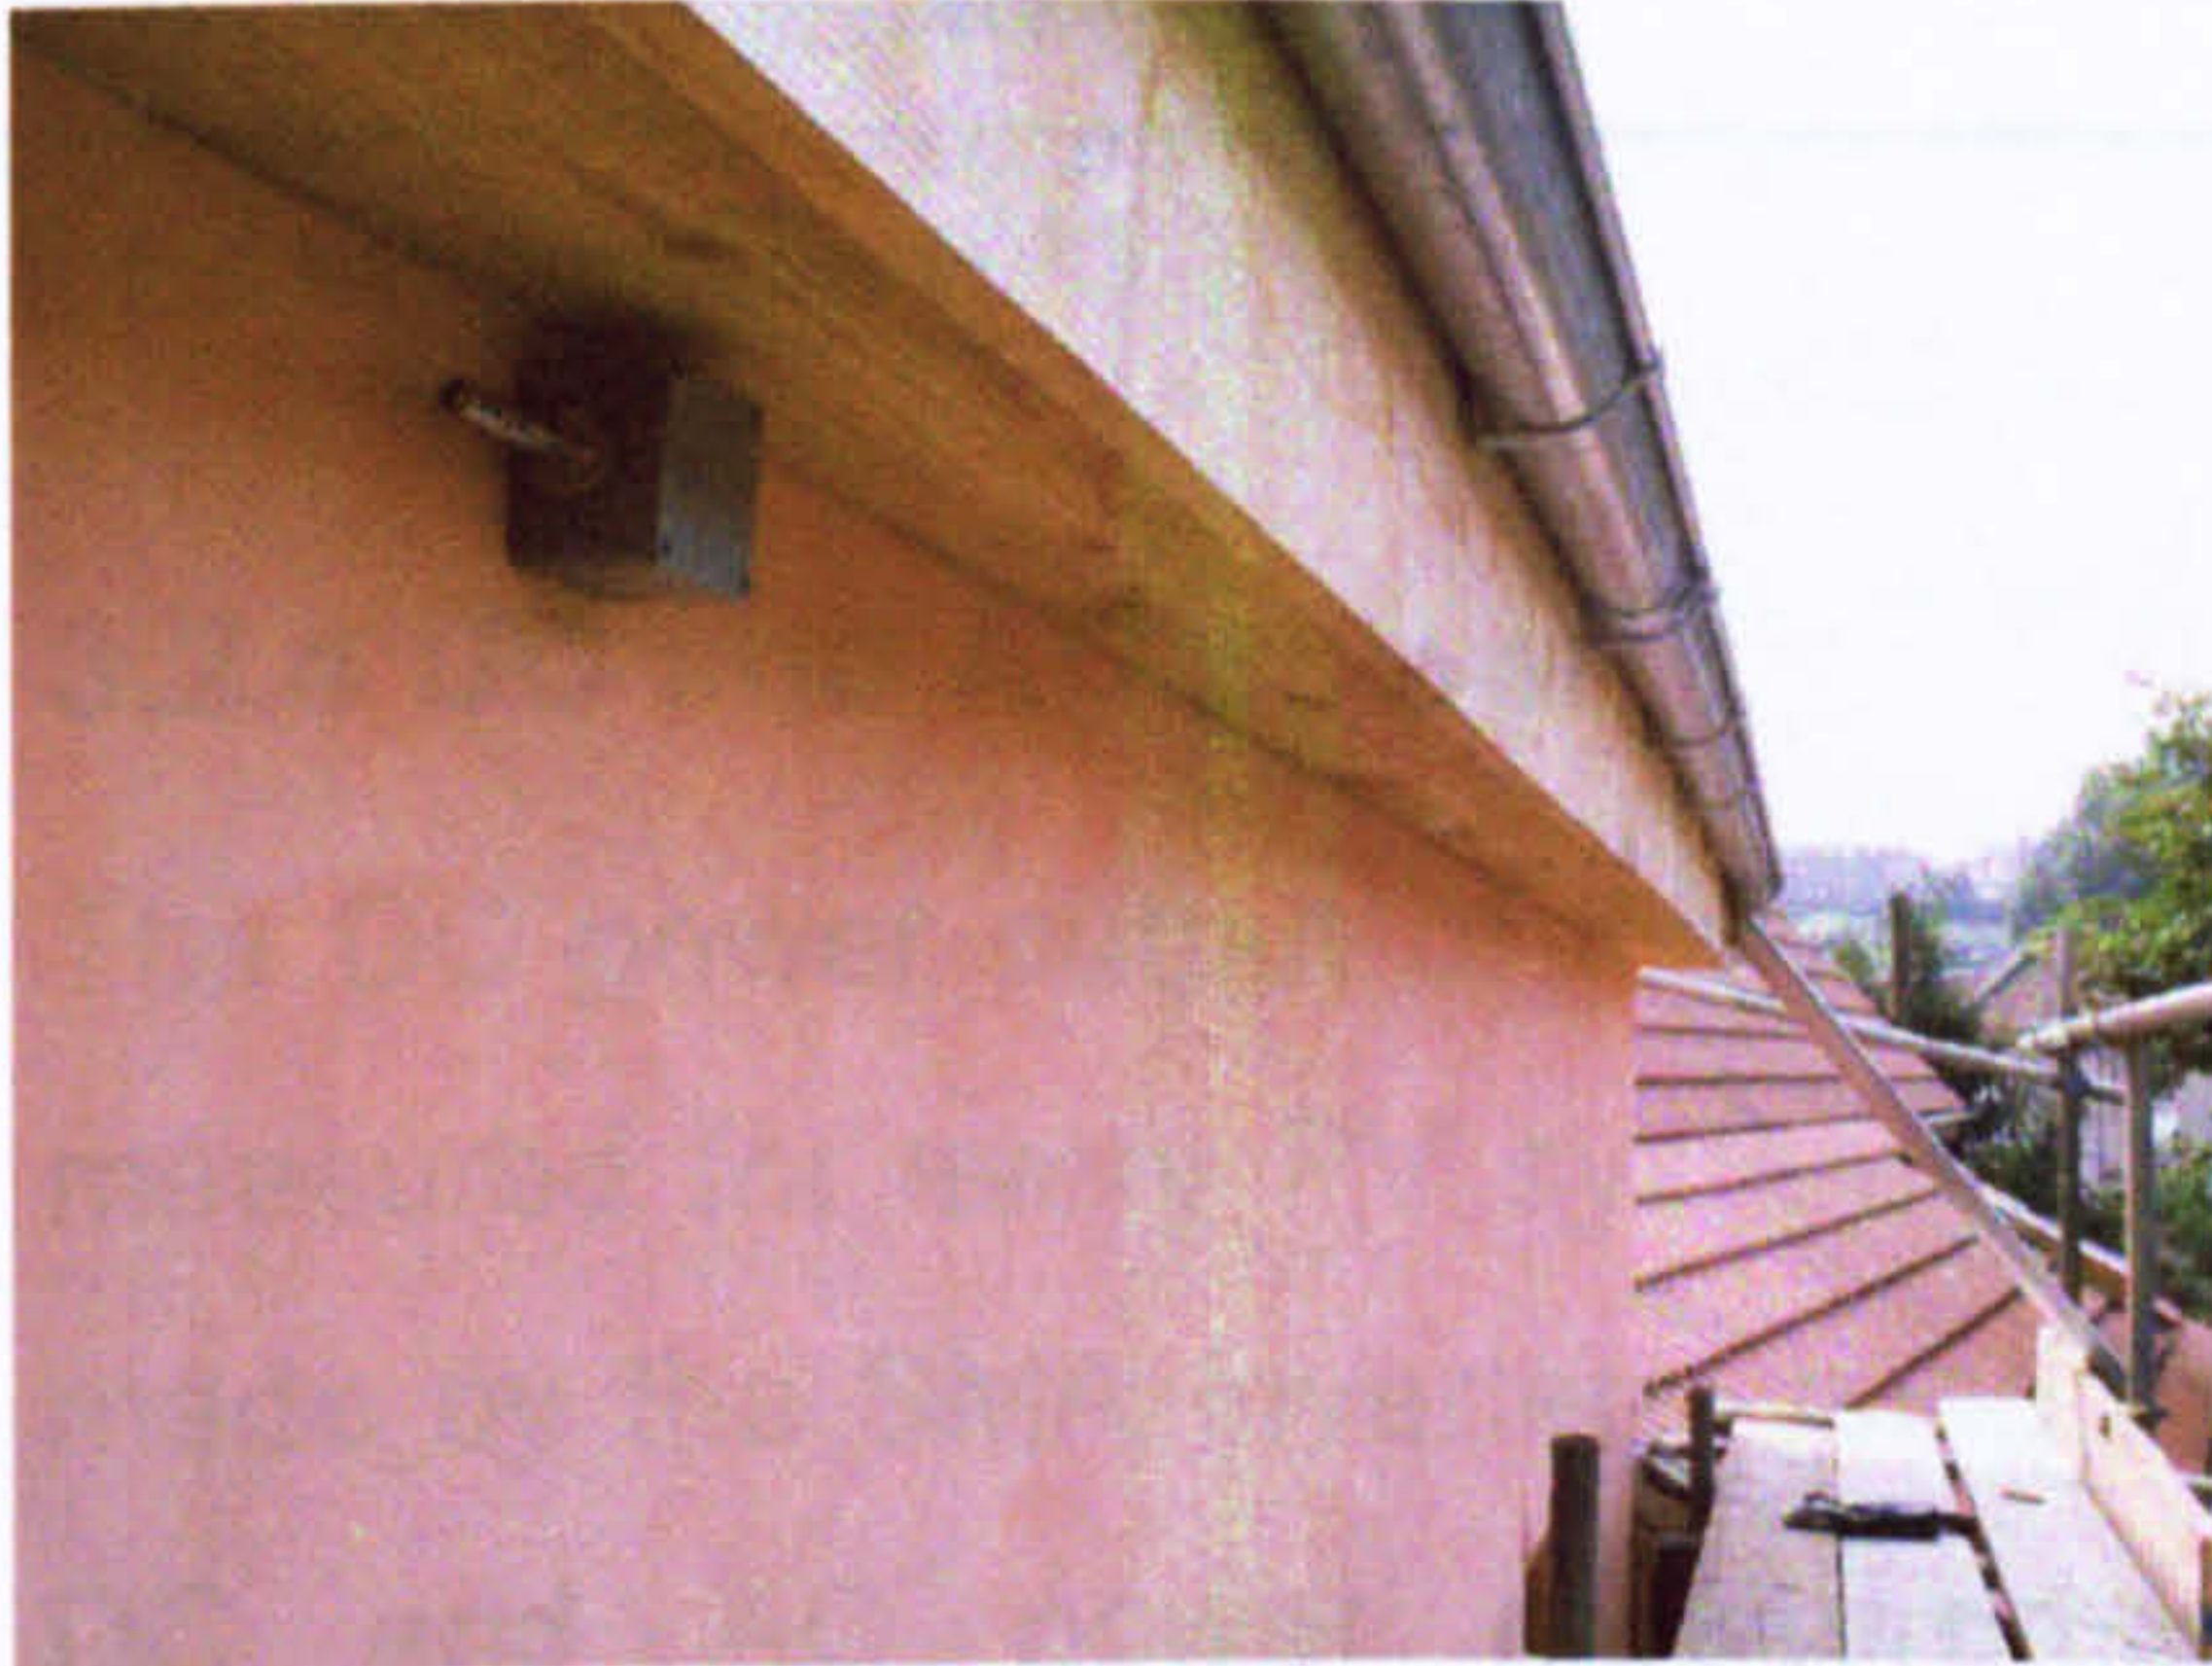
Figure 3-8: Ambient temperature sensor at Ashley Vale. The sensor is placed under the eaves on the north side of the house to avoid any direct solar radiation.

module temperature for each group of PV arrays with similar orientations. Ideally, the ambient air temperature sensor is placed out of direct sunlight and is usually located under the eaves of a roof on the north side of a house (Figure 3-8). The PV module temperature sensor was fixed to the underside of a PV module, preferably at the centre of the module and at the centre of a cell (Figure 3-9). Although the temperature of a PV array will vary at different locations of the array, only a single temperature measurement was made.

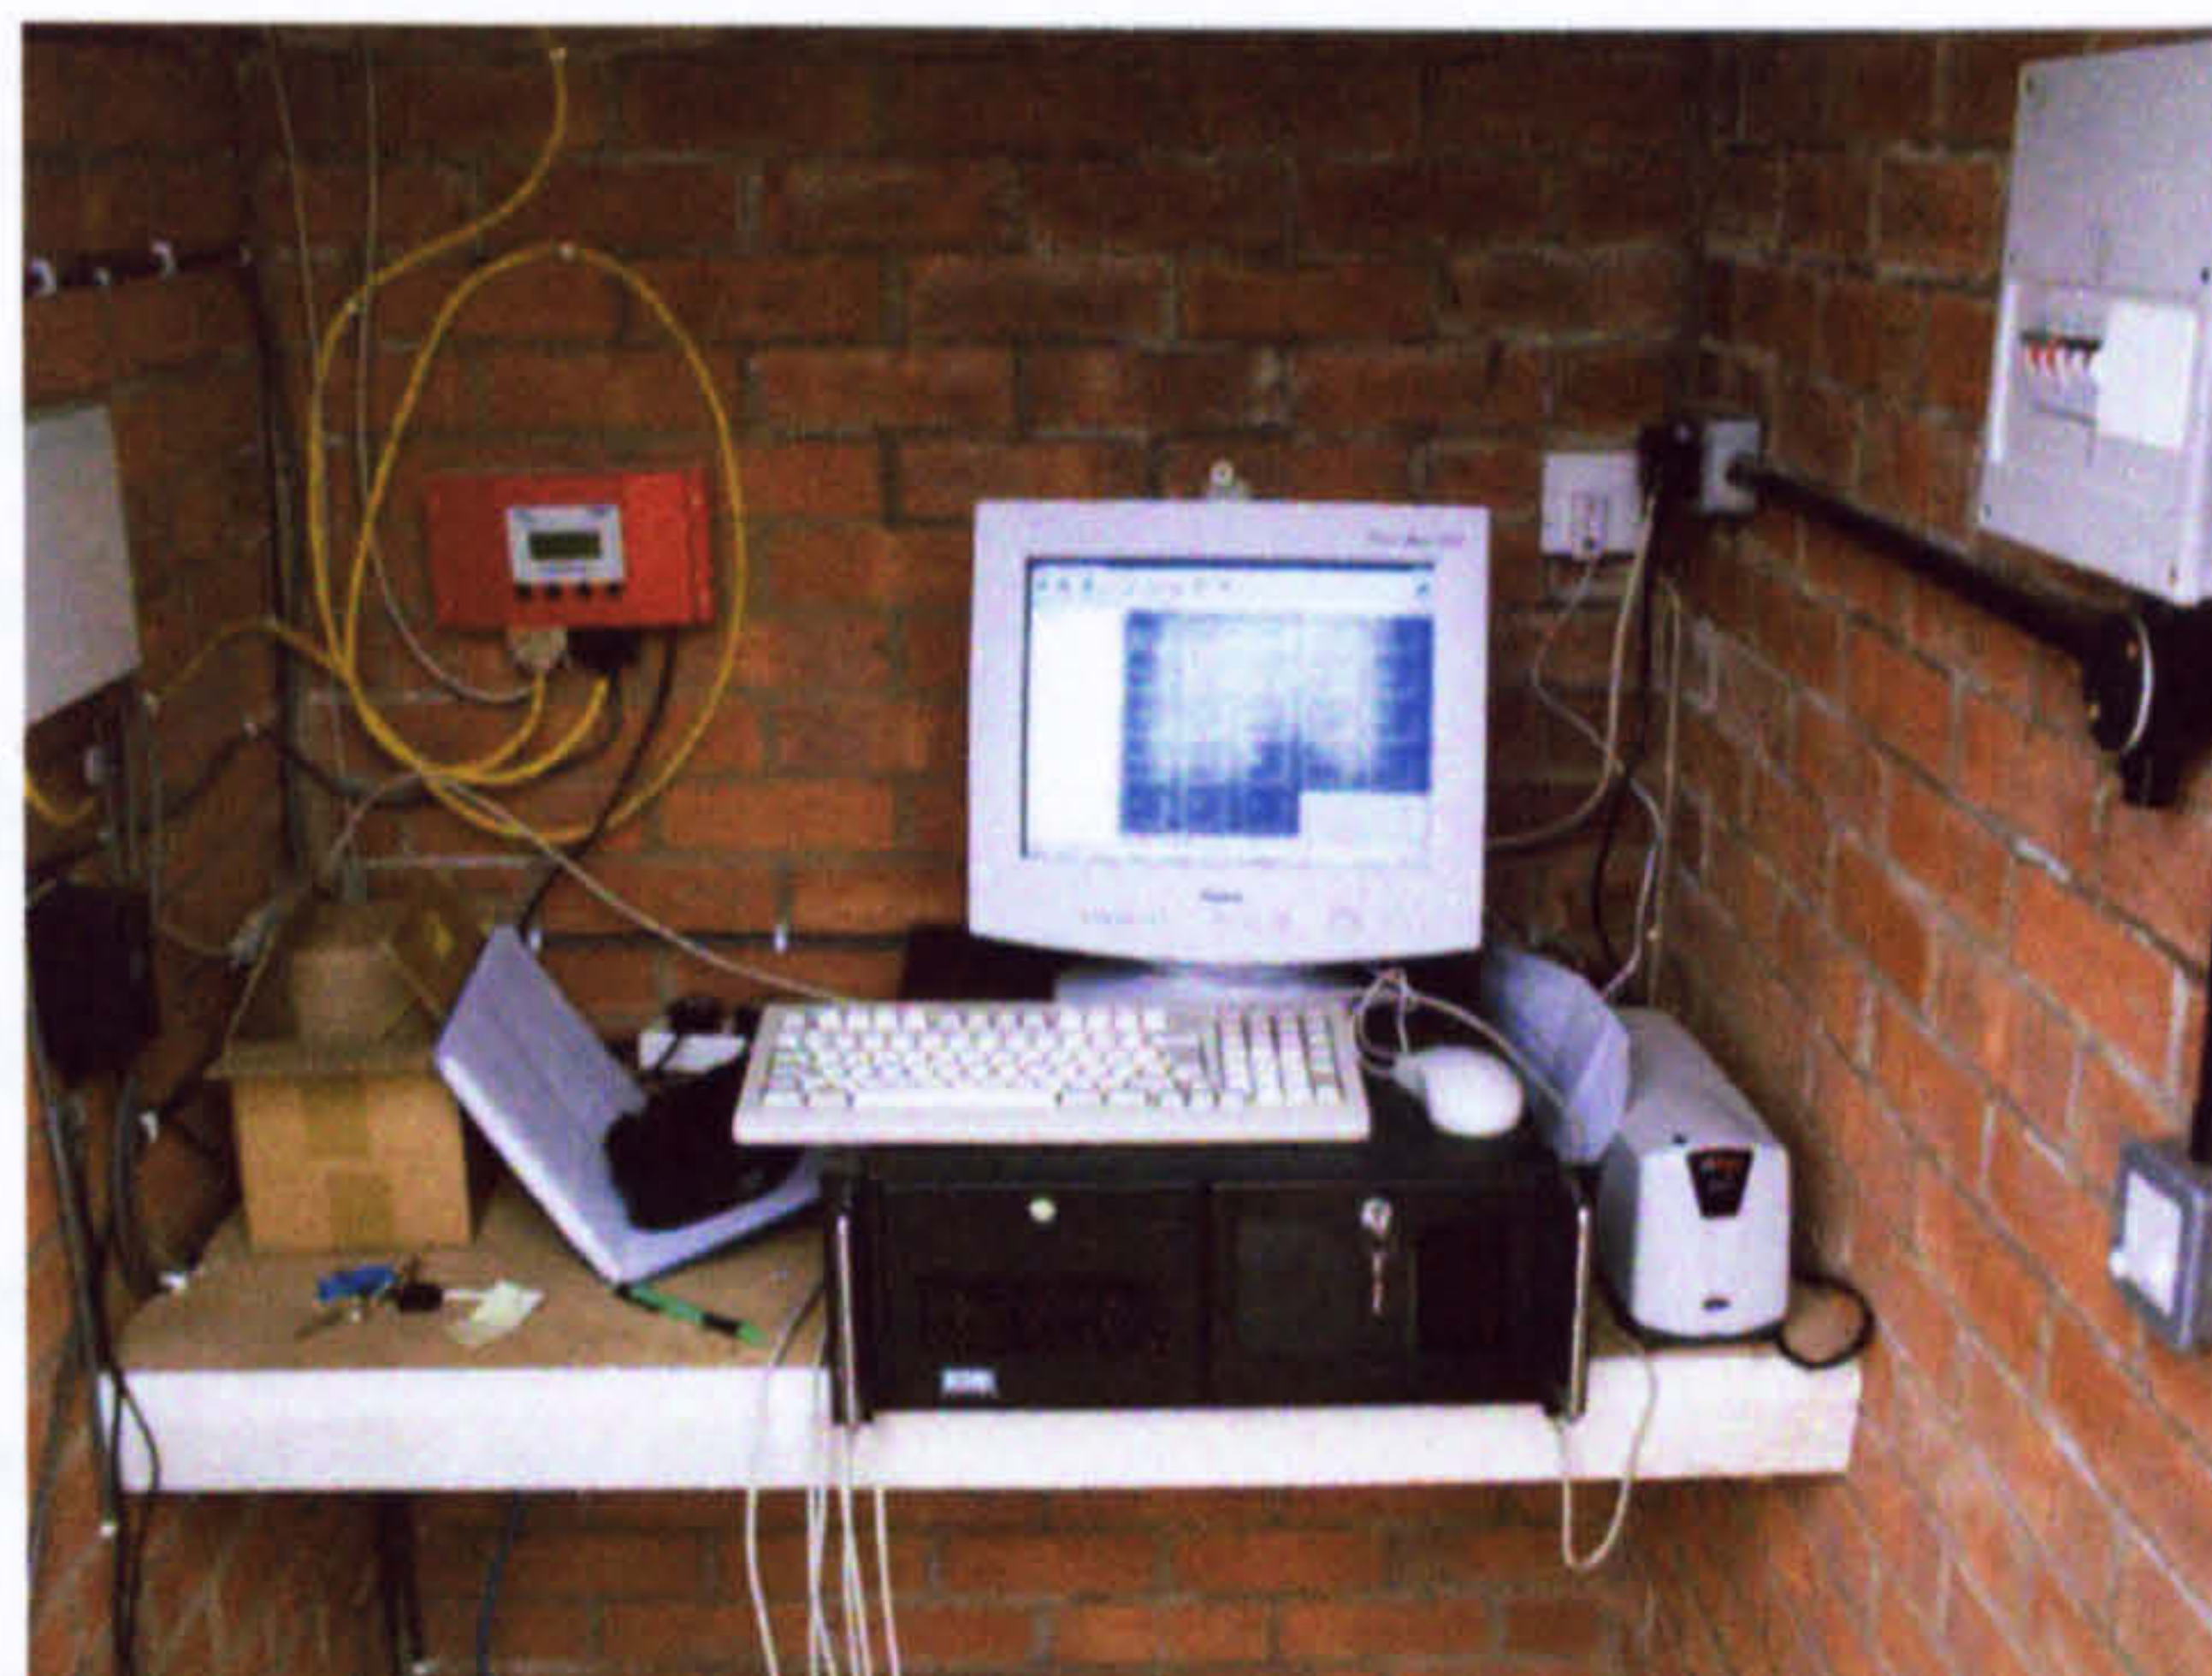
Figure 3-11: PC monitoring system at Corncroft

Corncroft and Newbiggin Hall used PCs to support the data collection. A PC was used to record and store the measured parameters, and was connected to a single modem and phone line for data transfer (Figure 3-11). At Corncroft a single SBC+ unit was used to monitor the AC and DC measured parameters and the data was transferred to the PC daily. At Newbiggin Hall all the measured parameters were recorded directly by the PC. In both cases the sampling rate was slow (at around 60 seconds or greater) for all the measured parameters as the monitoring systems had to cycle through each of the PV systems. This sampling rate was outside the DFT monitoring specification for some of measured parameters and the consequence of the slow sampling rate is discussed in Section 4.2.4.
